TS-AMD-86612-3
September 1987

AERIAL PHOTOGRAPHIC ANALYSIS OF
THE UNION OIL REFINERY SITE

Lemont, Illinois

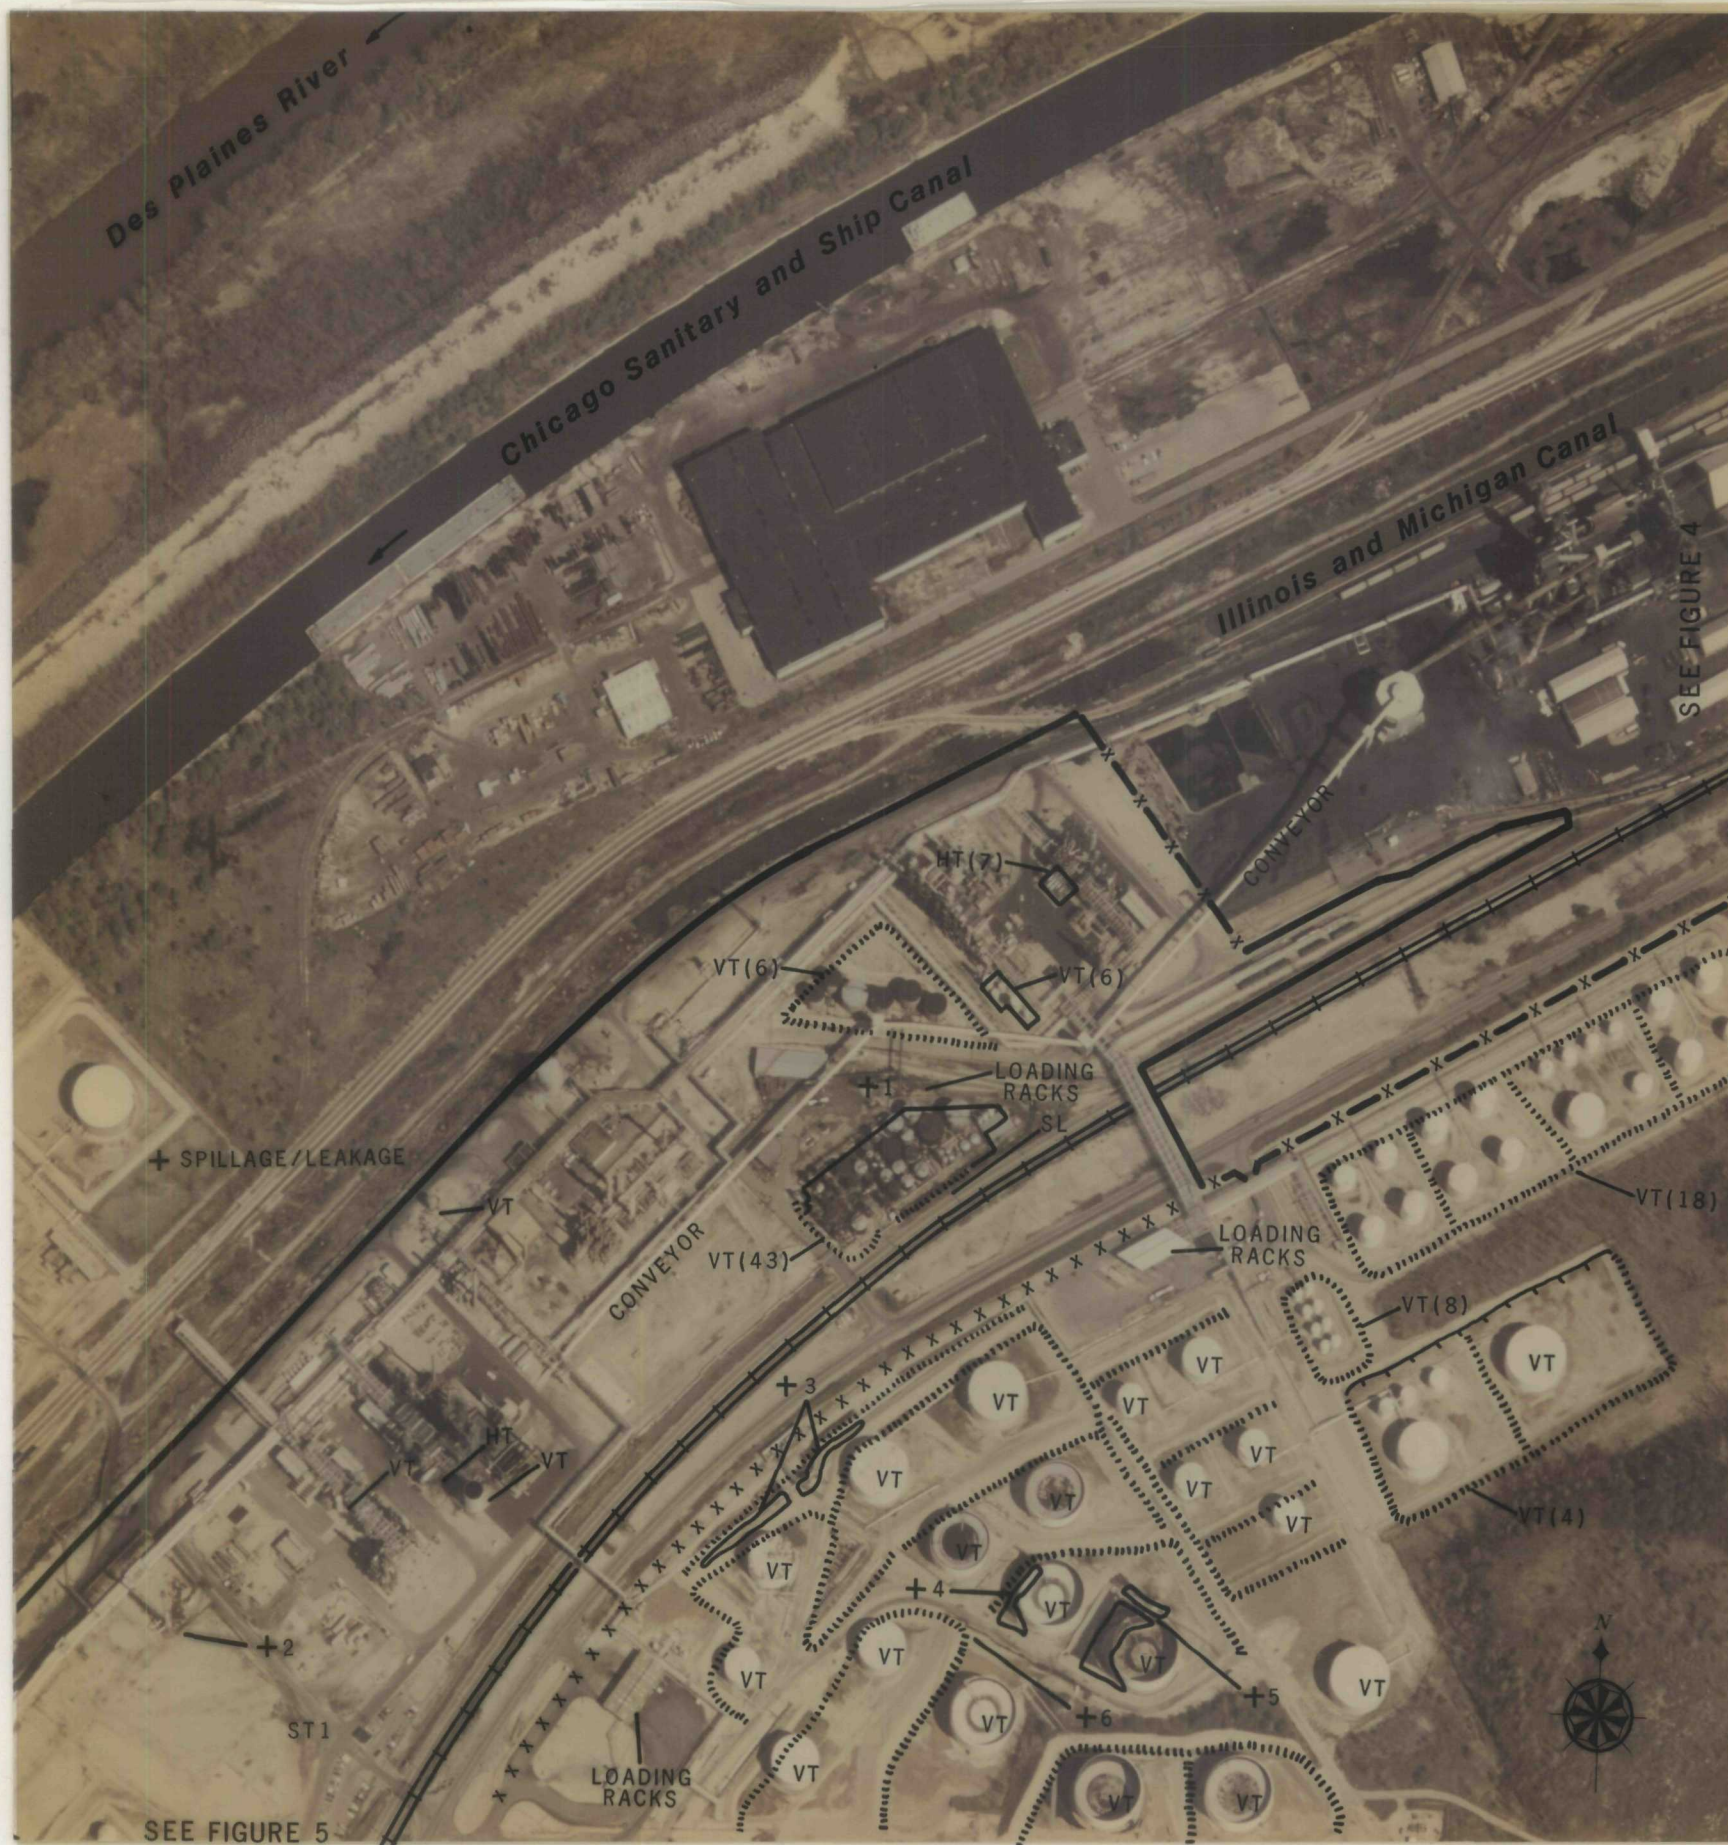
Figure 3. Union Oil Refinery site, April 17, 1986 (1 of 9). Approximate scale 1:5,000.

| +1 | Spillage at #1 consists of pools of product on the ground below loading racks. |
| +2 | Number 2 is an older spill of oily liquid originating at the adjacent flare tower. |
| +3 | Extensive spillage at #3 lies within a containment dike; however, the source is not apparent. |
| +6 | Number 6 is an older spill which appears to be the result of uncontrolled dumping on the roadway. |
| ST1 | Staining at #1 is an old spill on open ground. Due to its location it may be the result of a tank truck spill. |

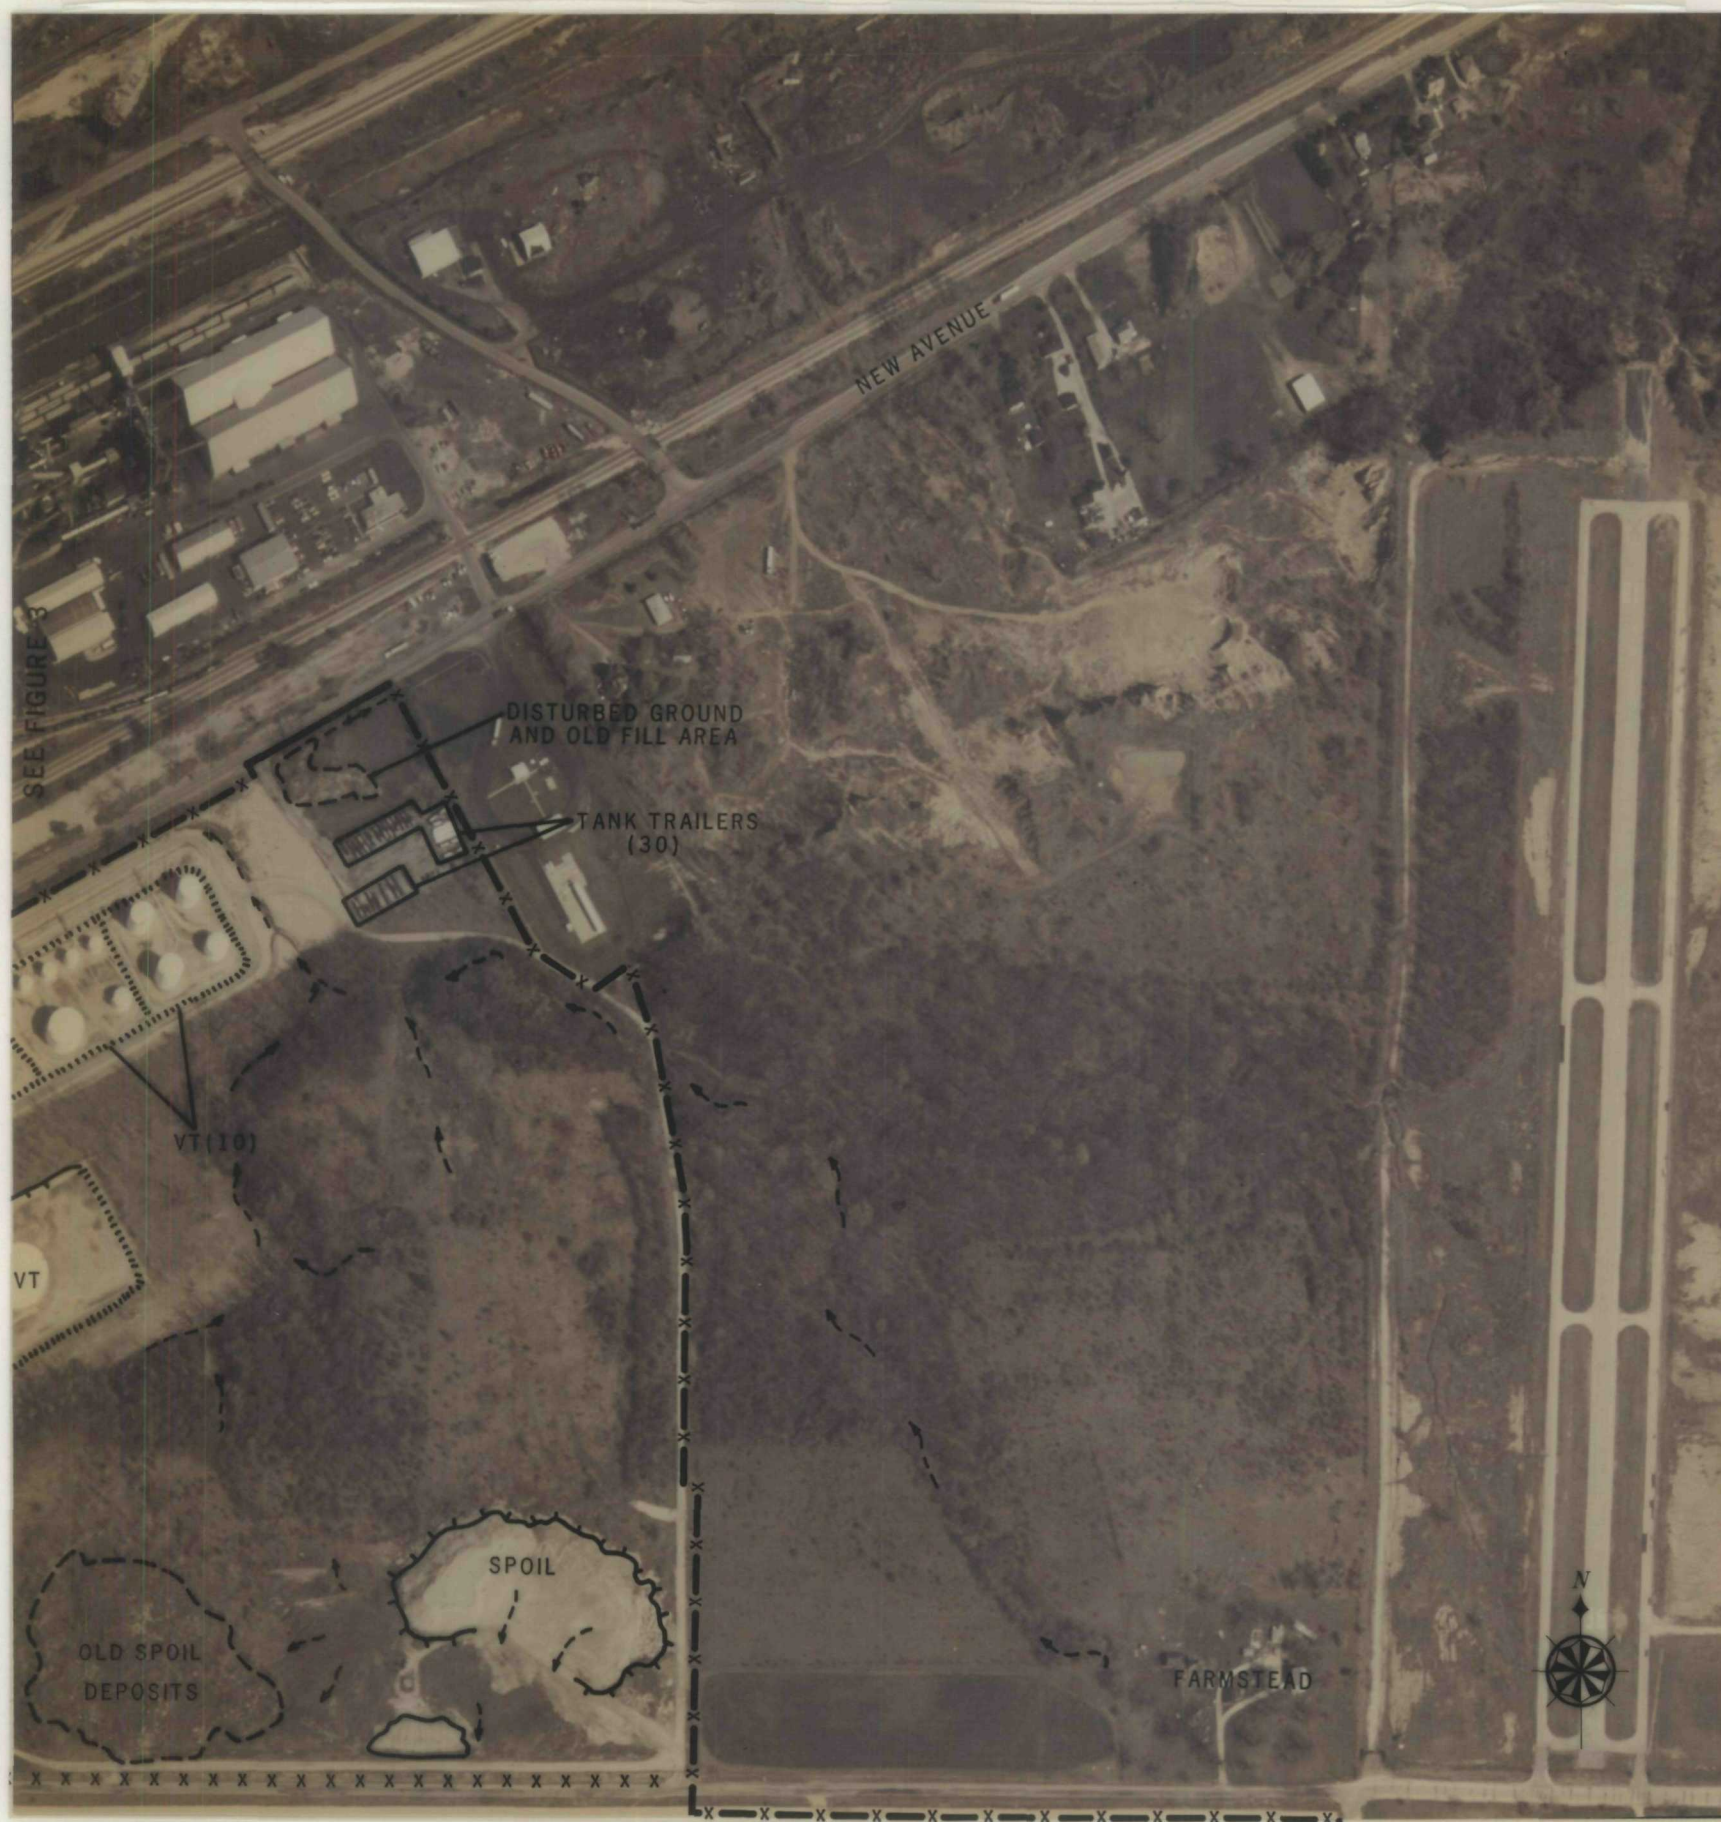
Figure 4. Union Oil Refinery site, April 17, 1986 (2 of 9). Approximate scale 1:5,000.

The old fill area and spoil deposits are potential waste burial areas; however, no visible evidence of waste disposal activity or other contamination source is evident. No leakage is visible at the tank trailers.

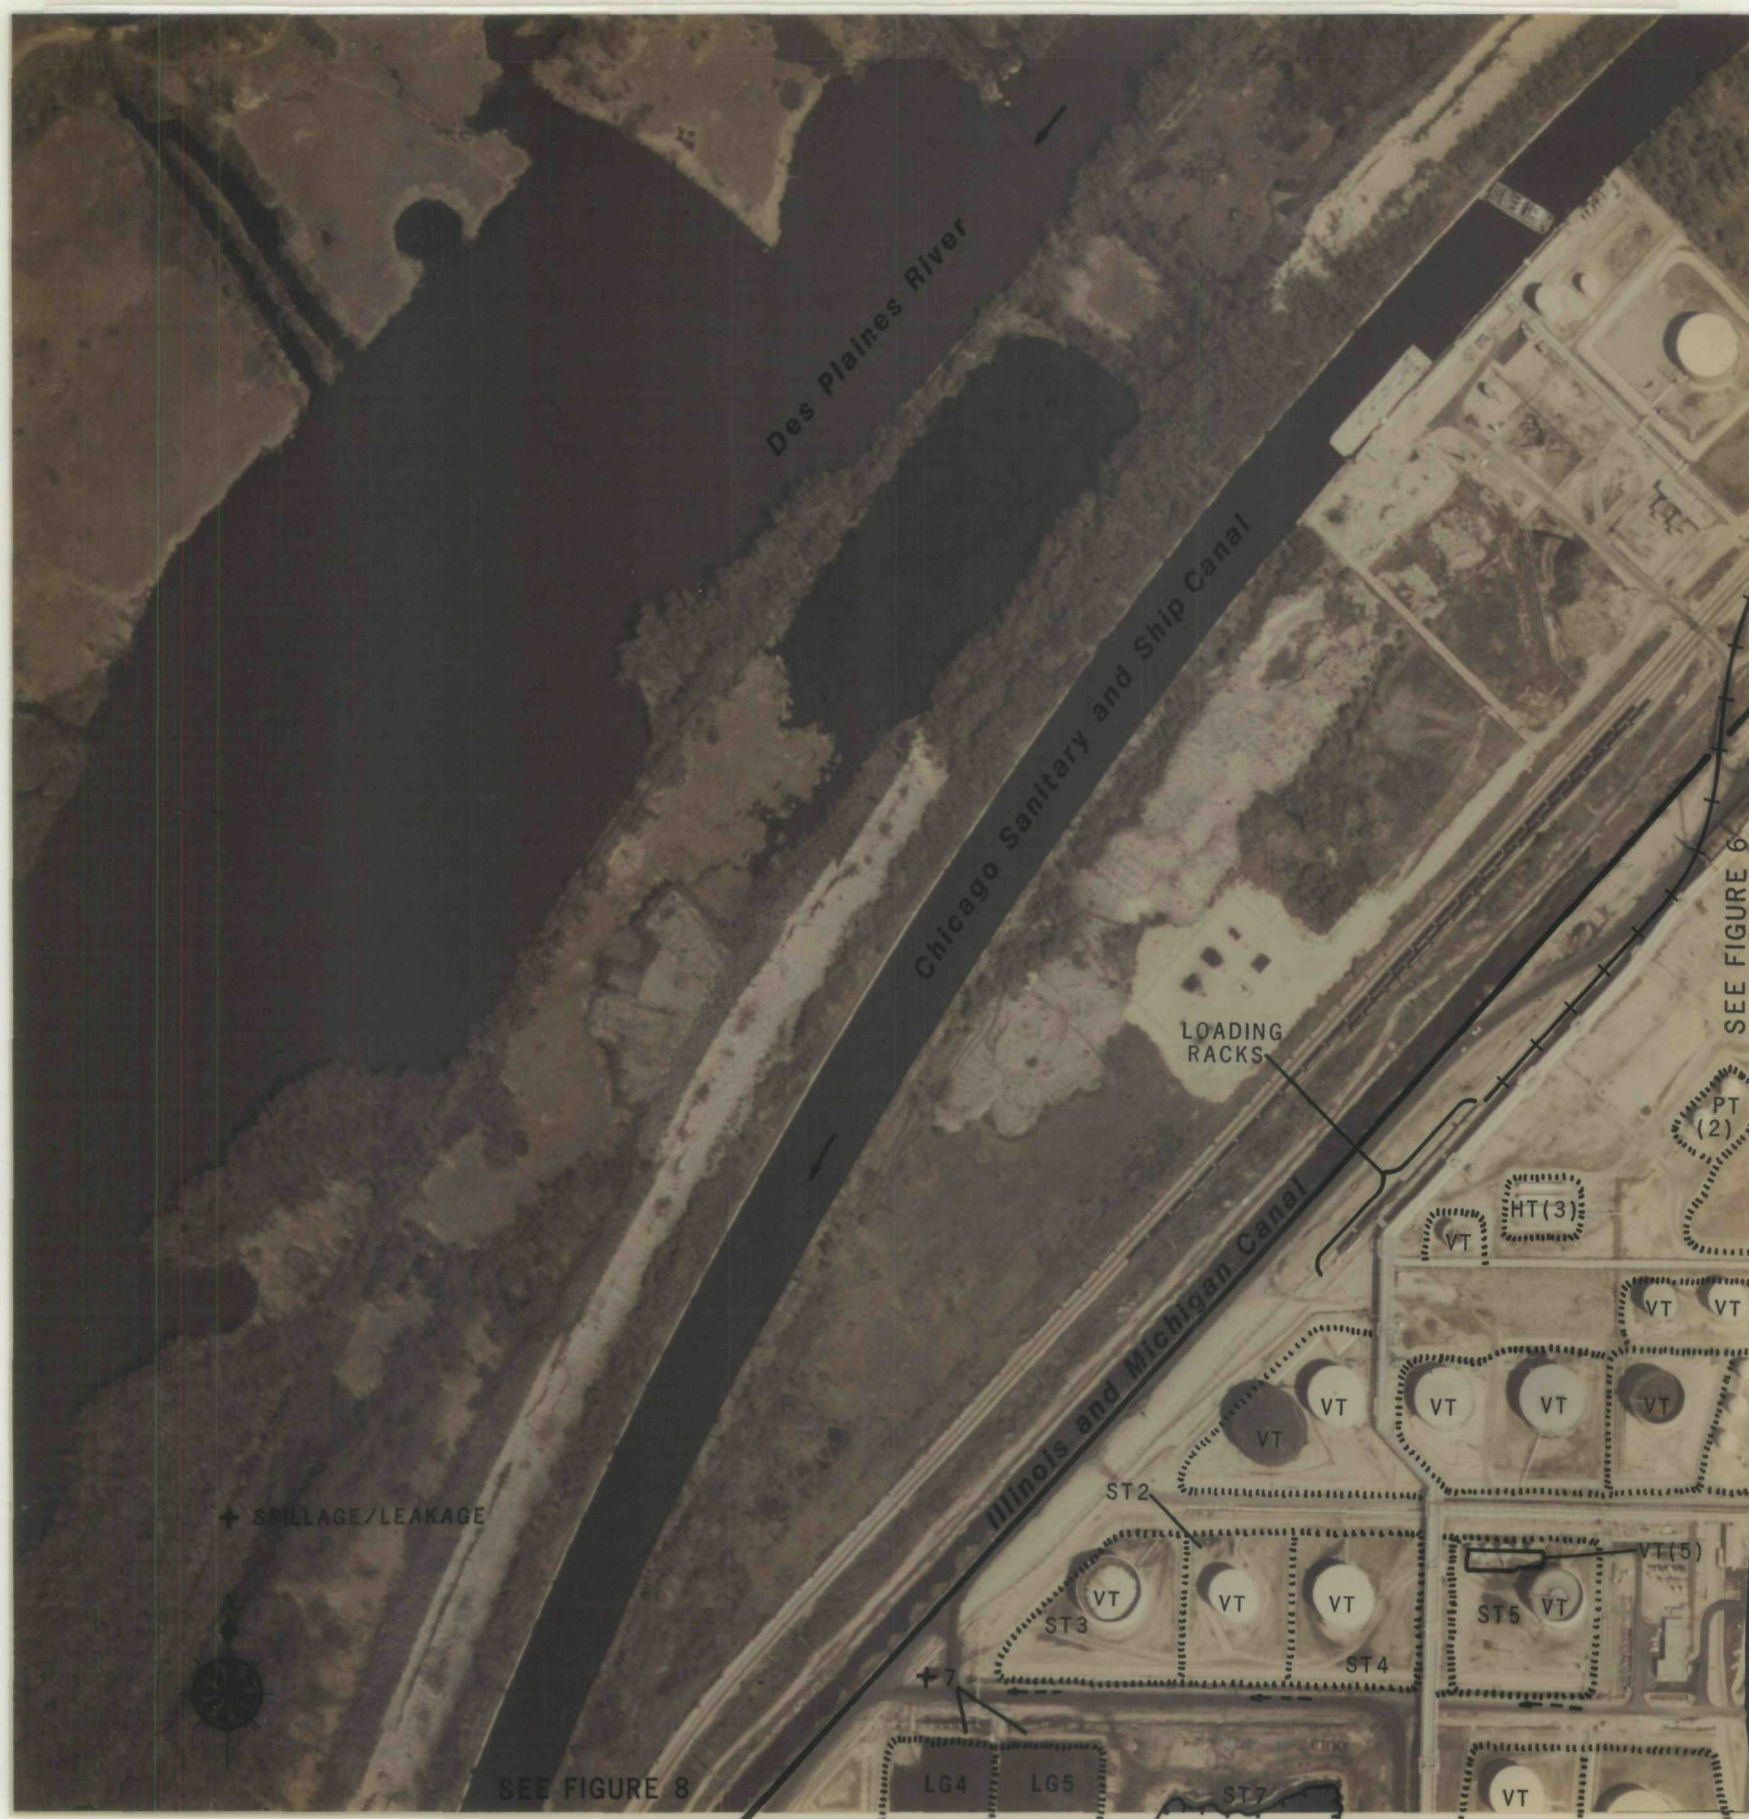
Figure 5. Union Oil Refinery site, April 17, 1986 (3 of 9). Approximate scale 1:5,000.

- Spills at this point consist of dark liquid apparently originating at an adjacent pipeline.

- These stains are dark-toned stains within containment dikes which are the results of old spills.

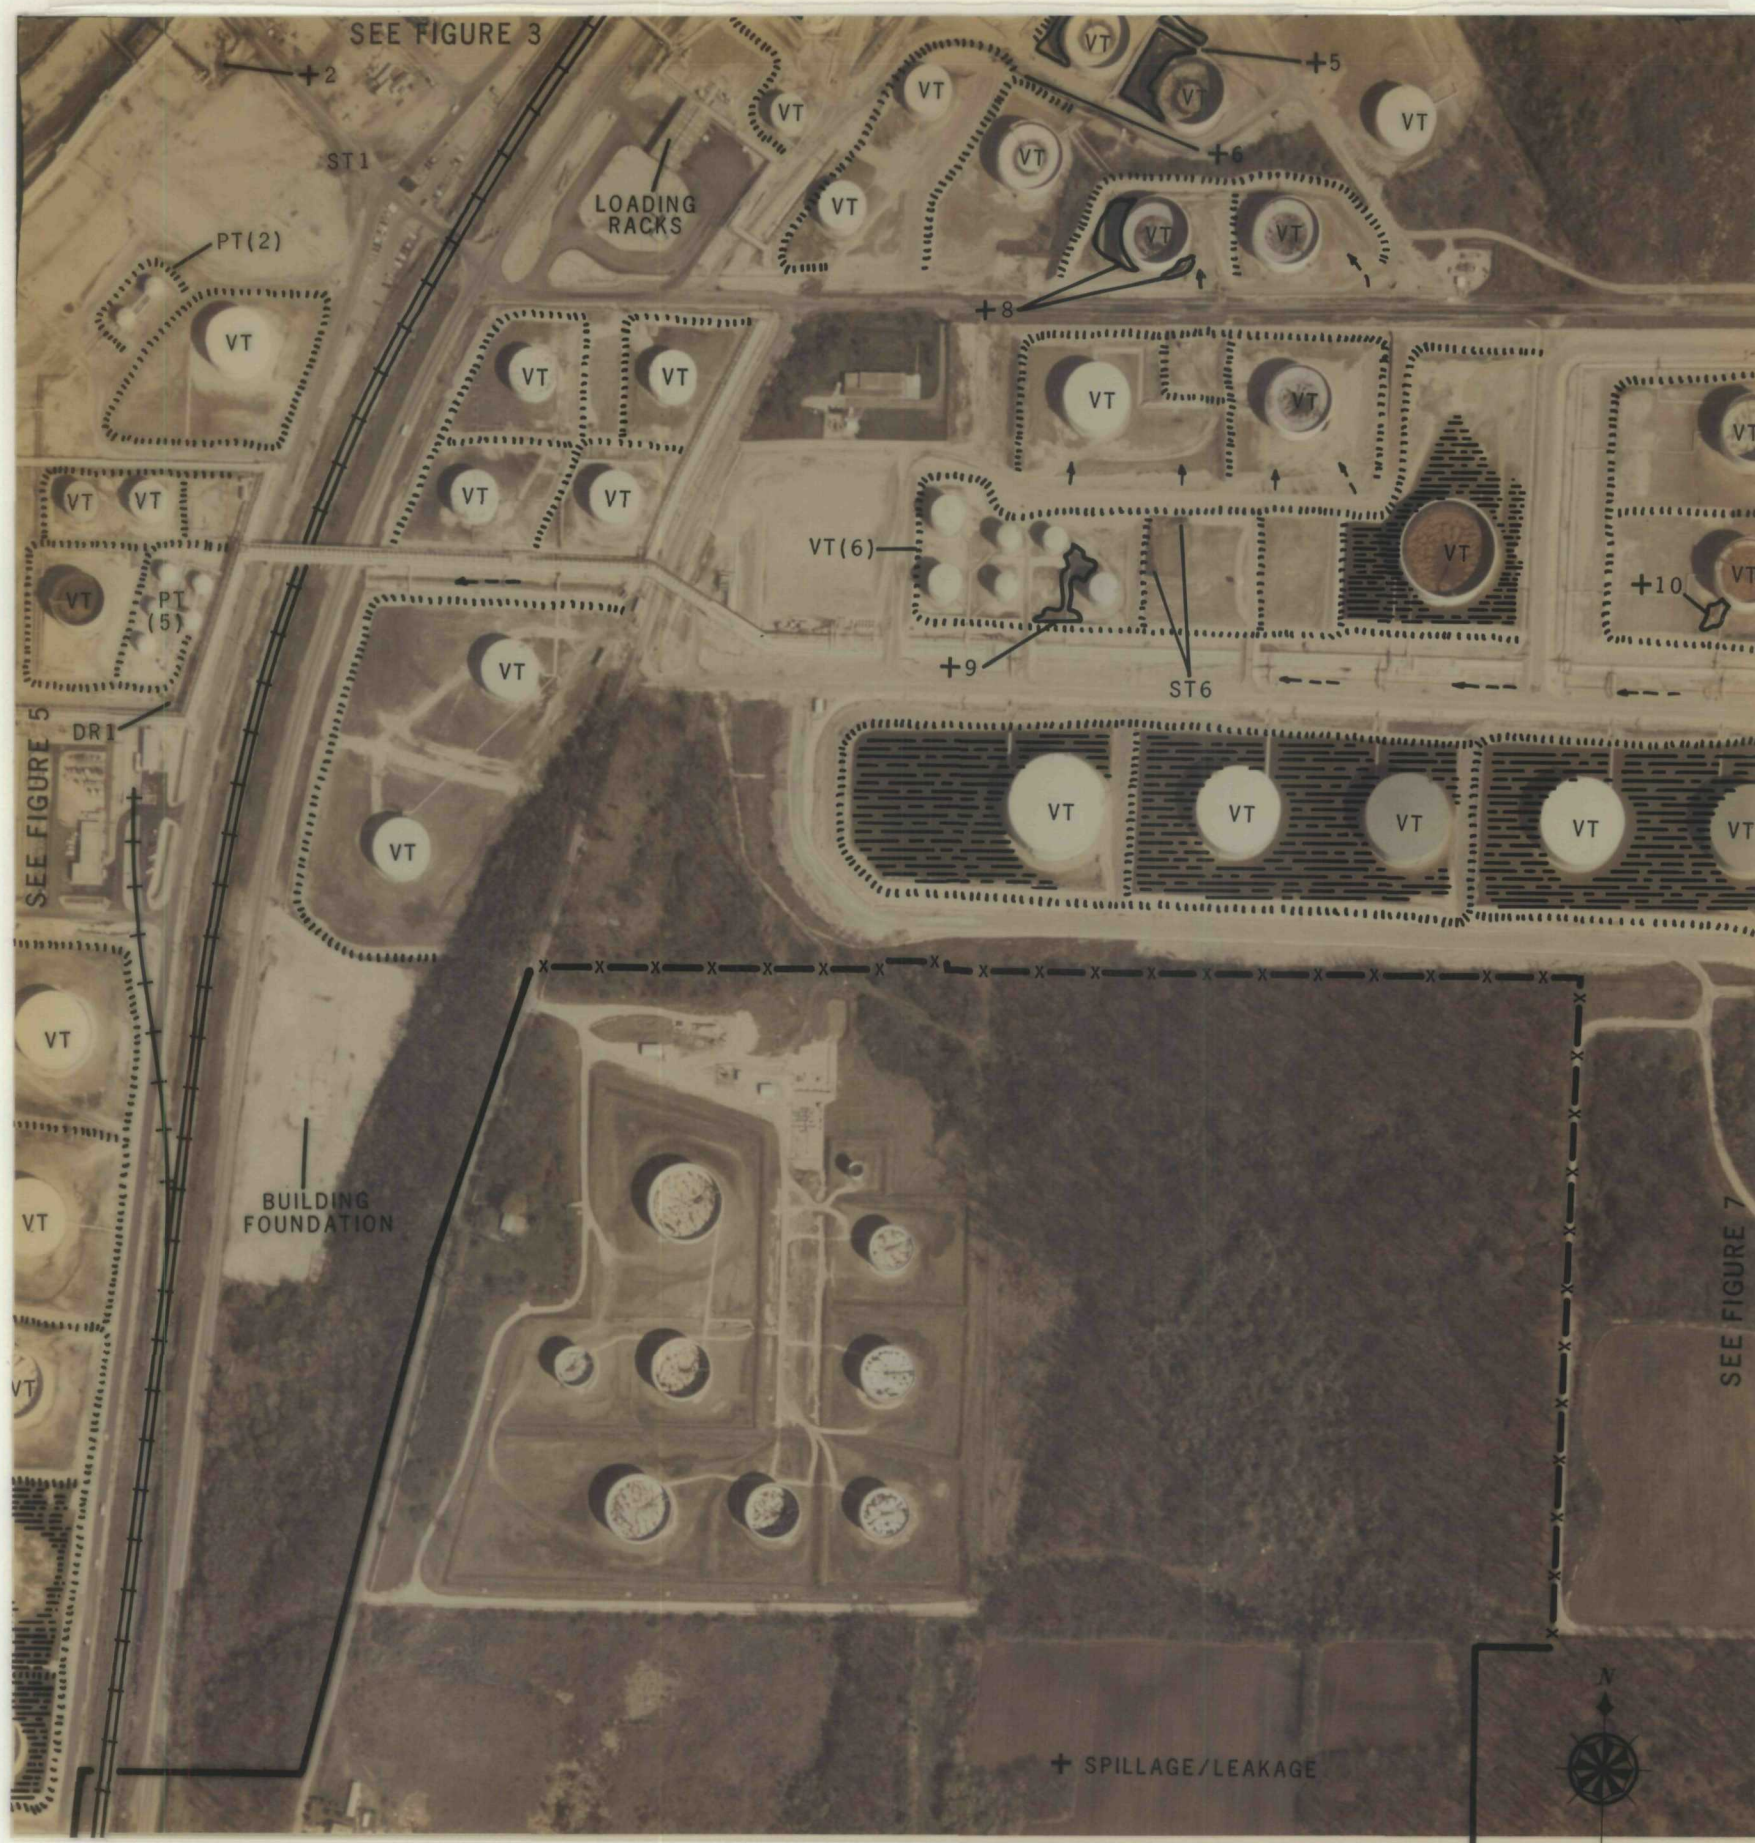
Figure 6. Union Oil Refinery site, April 17, 1986 (4 of 9). Approximate scale 1:5,000.

Large amounts of standing liquid are noted in several of the tank containments.

- +8 and 9 - Spillage at these points are extensive accumulations of oil product which originate at adjacent storage tanks. All of these spills lie within containment dikes.
- +10 - Small amounts of spillage at #10 is also associated with large storage tanks; however, the lighter orange hue distinguishes it from other spills.
- ST6 - This stain is a dark-toned stain within containment dikes which is the result of an old spill.
- DR1 - These are small accumulations of drums. No leakage is visible at either of them.

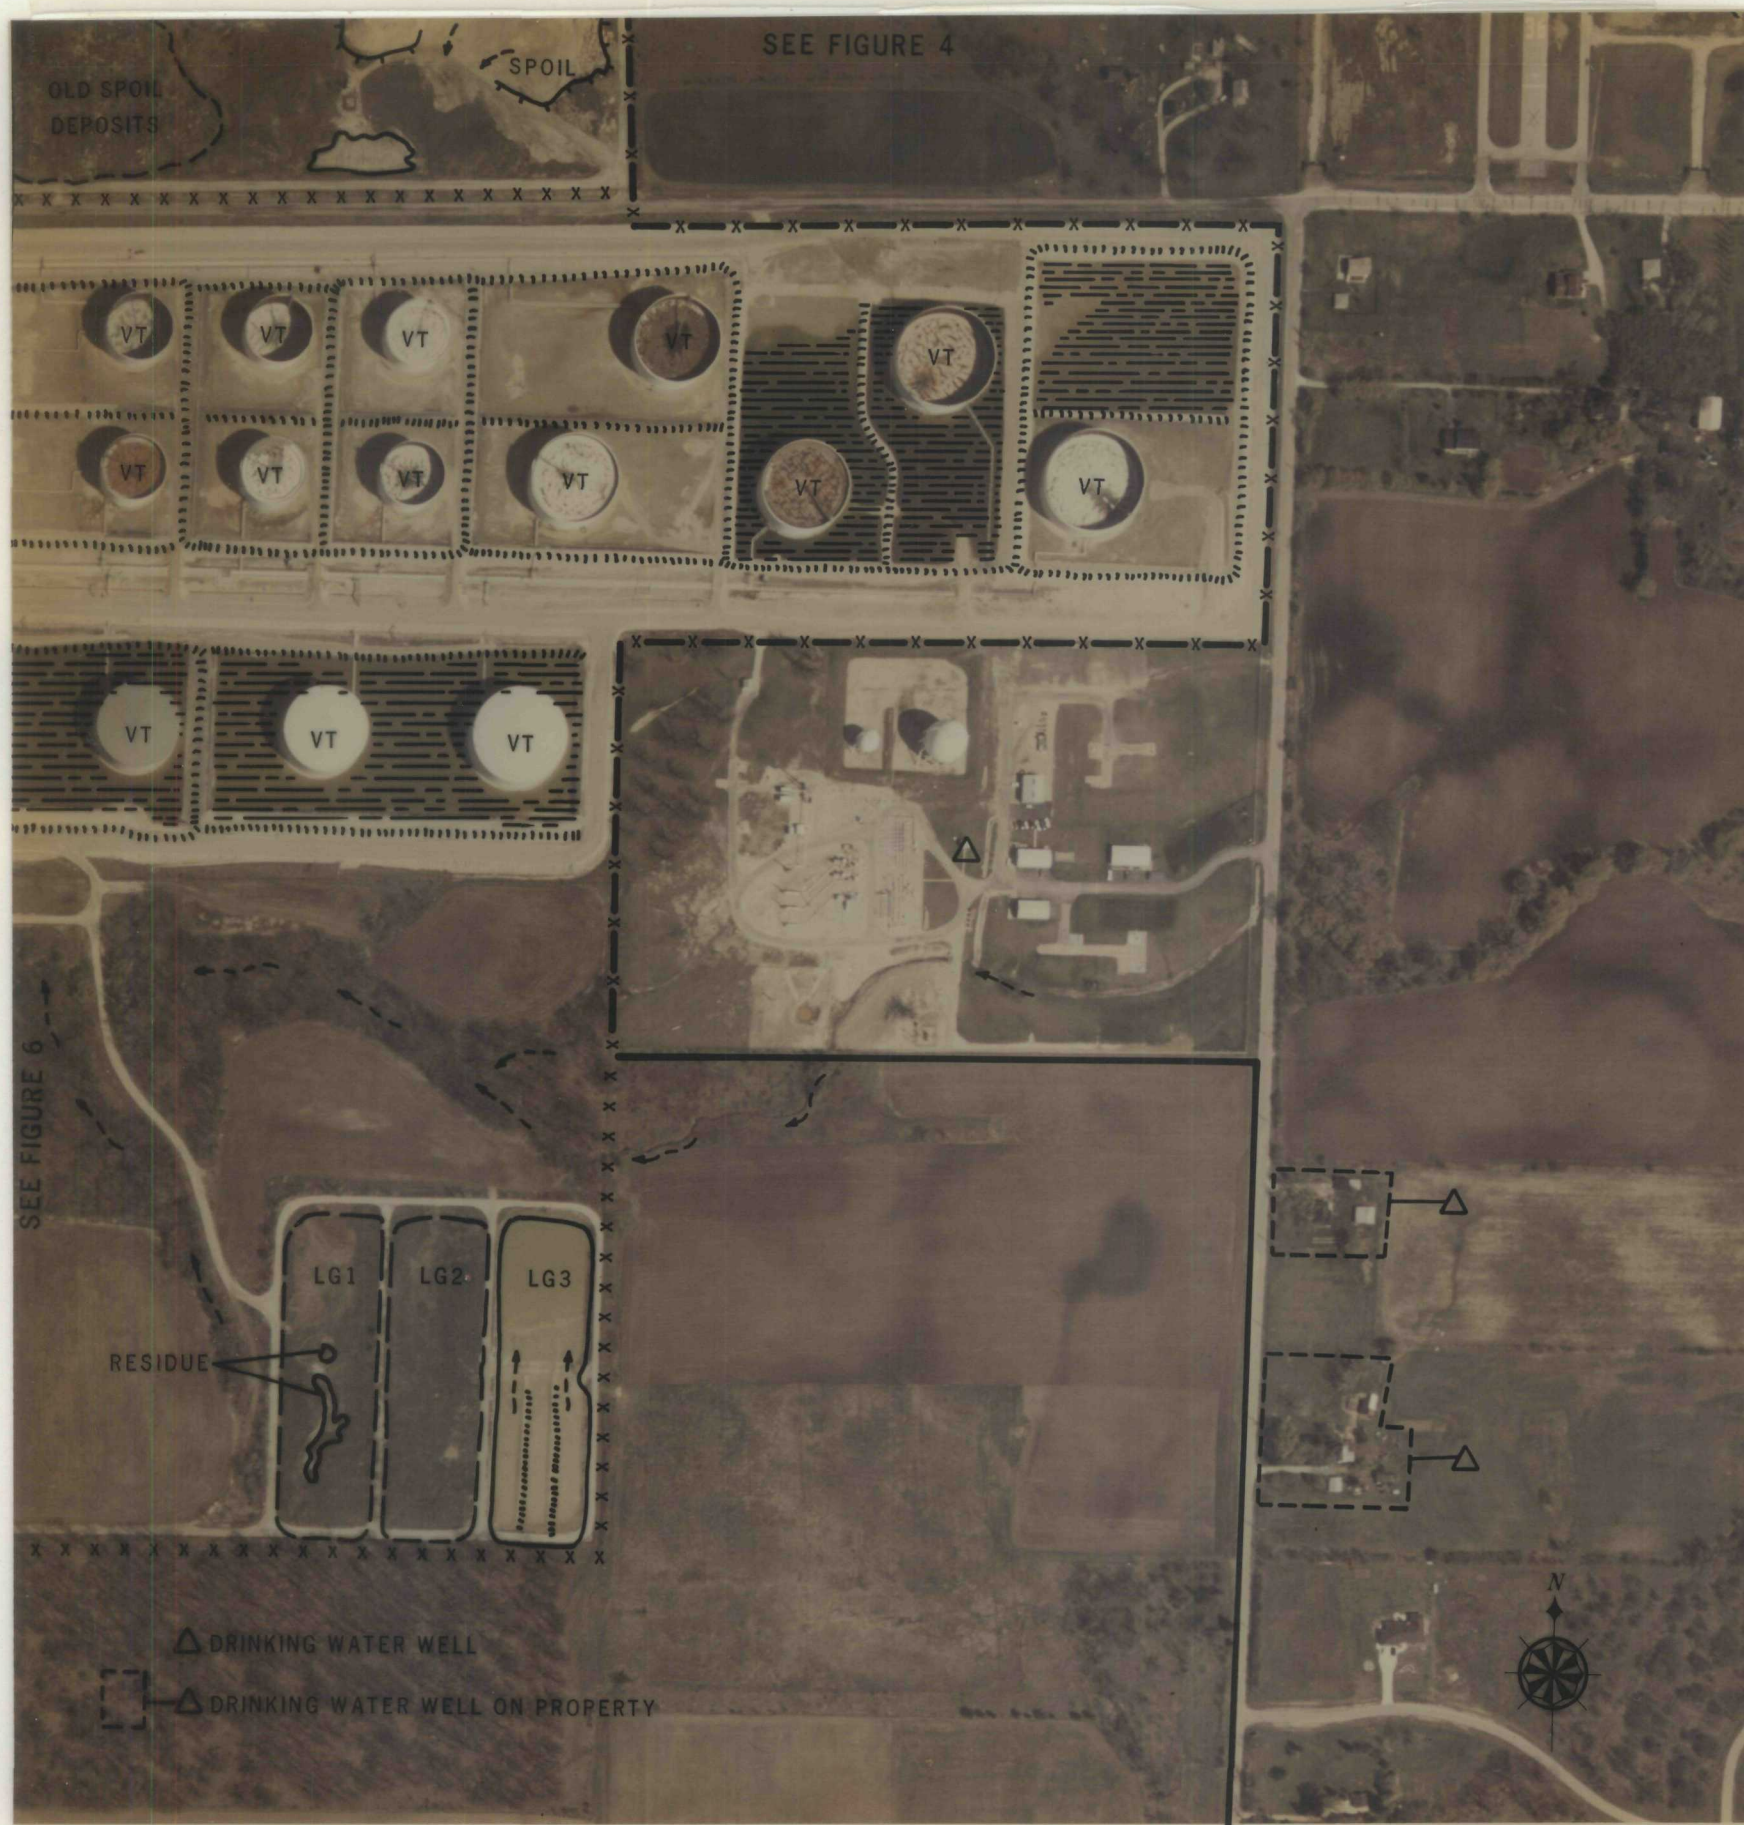
Figure 7. Union Oil Refinery site, April 17, 1986 (5 of 9). Approximate scale 1:5,000.

The approximate reported locations of three drinking water wells are depicted. Significant features are.

- LG1-3 - A complex of lagoons are located on the outskirts of the site. Number 3 is still active and contains a pale greenish liquid, possibly water. The purpose of these lagoons is not apparent.

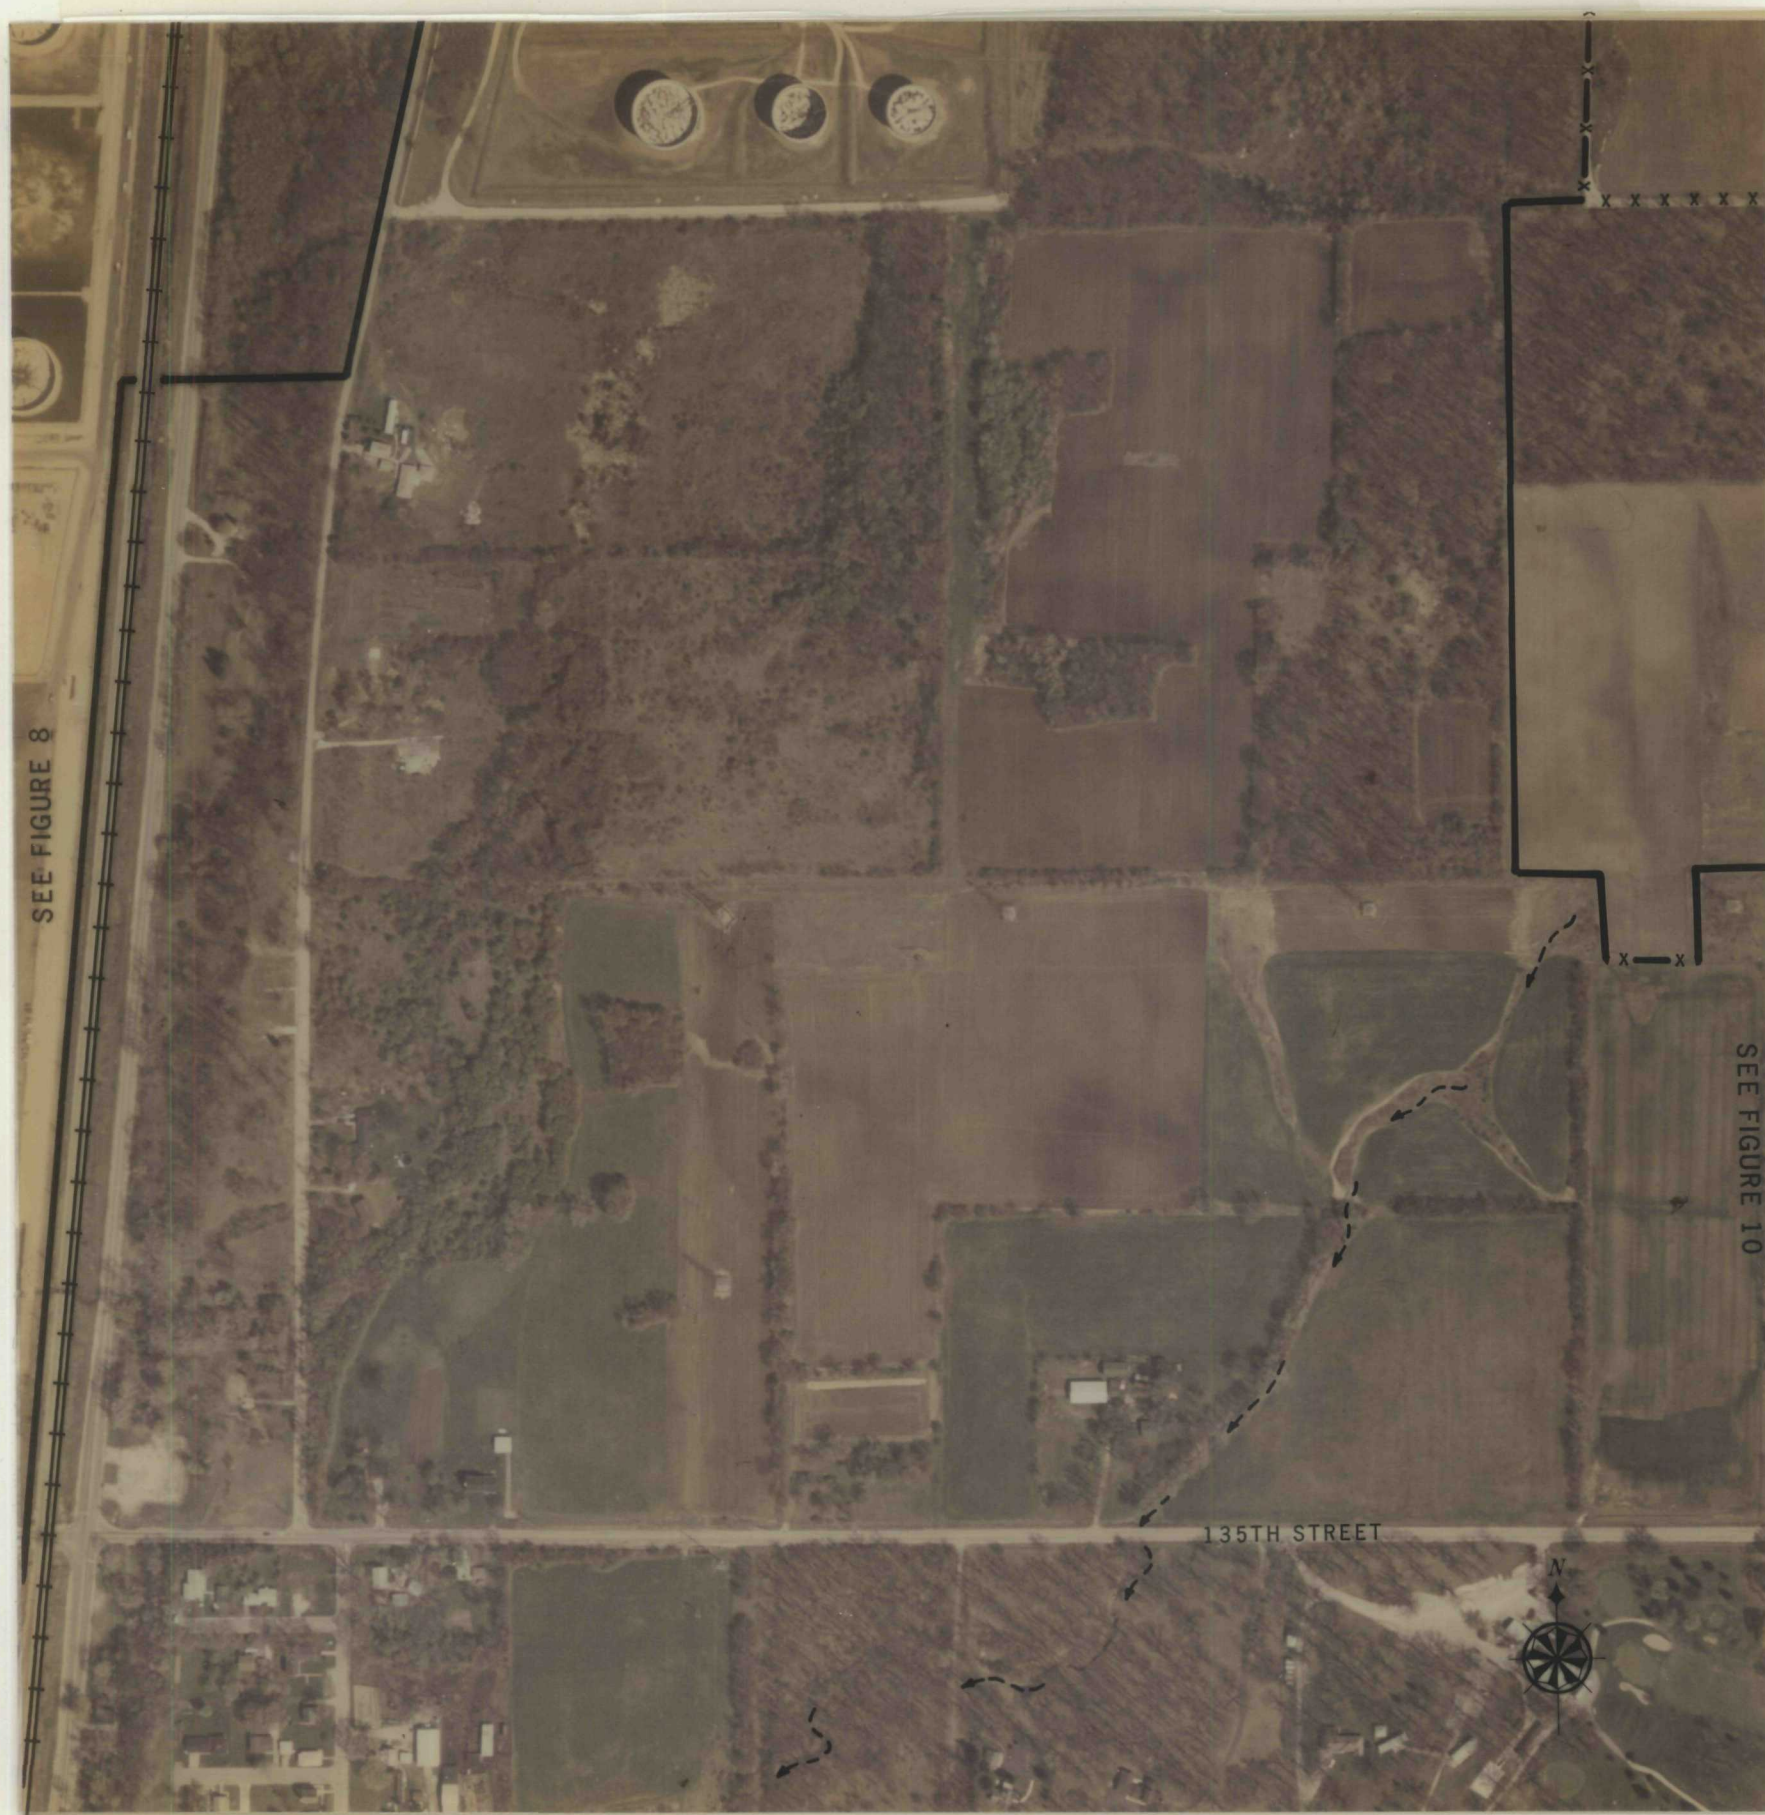
Figure 9. Union Oil Refinery site, April 17, 1986 (7 of 9). Approximate scale 1:5,000.

No significant features are observed.

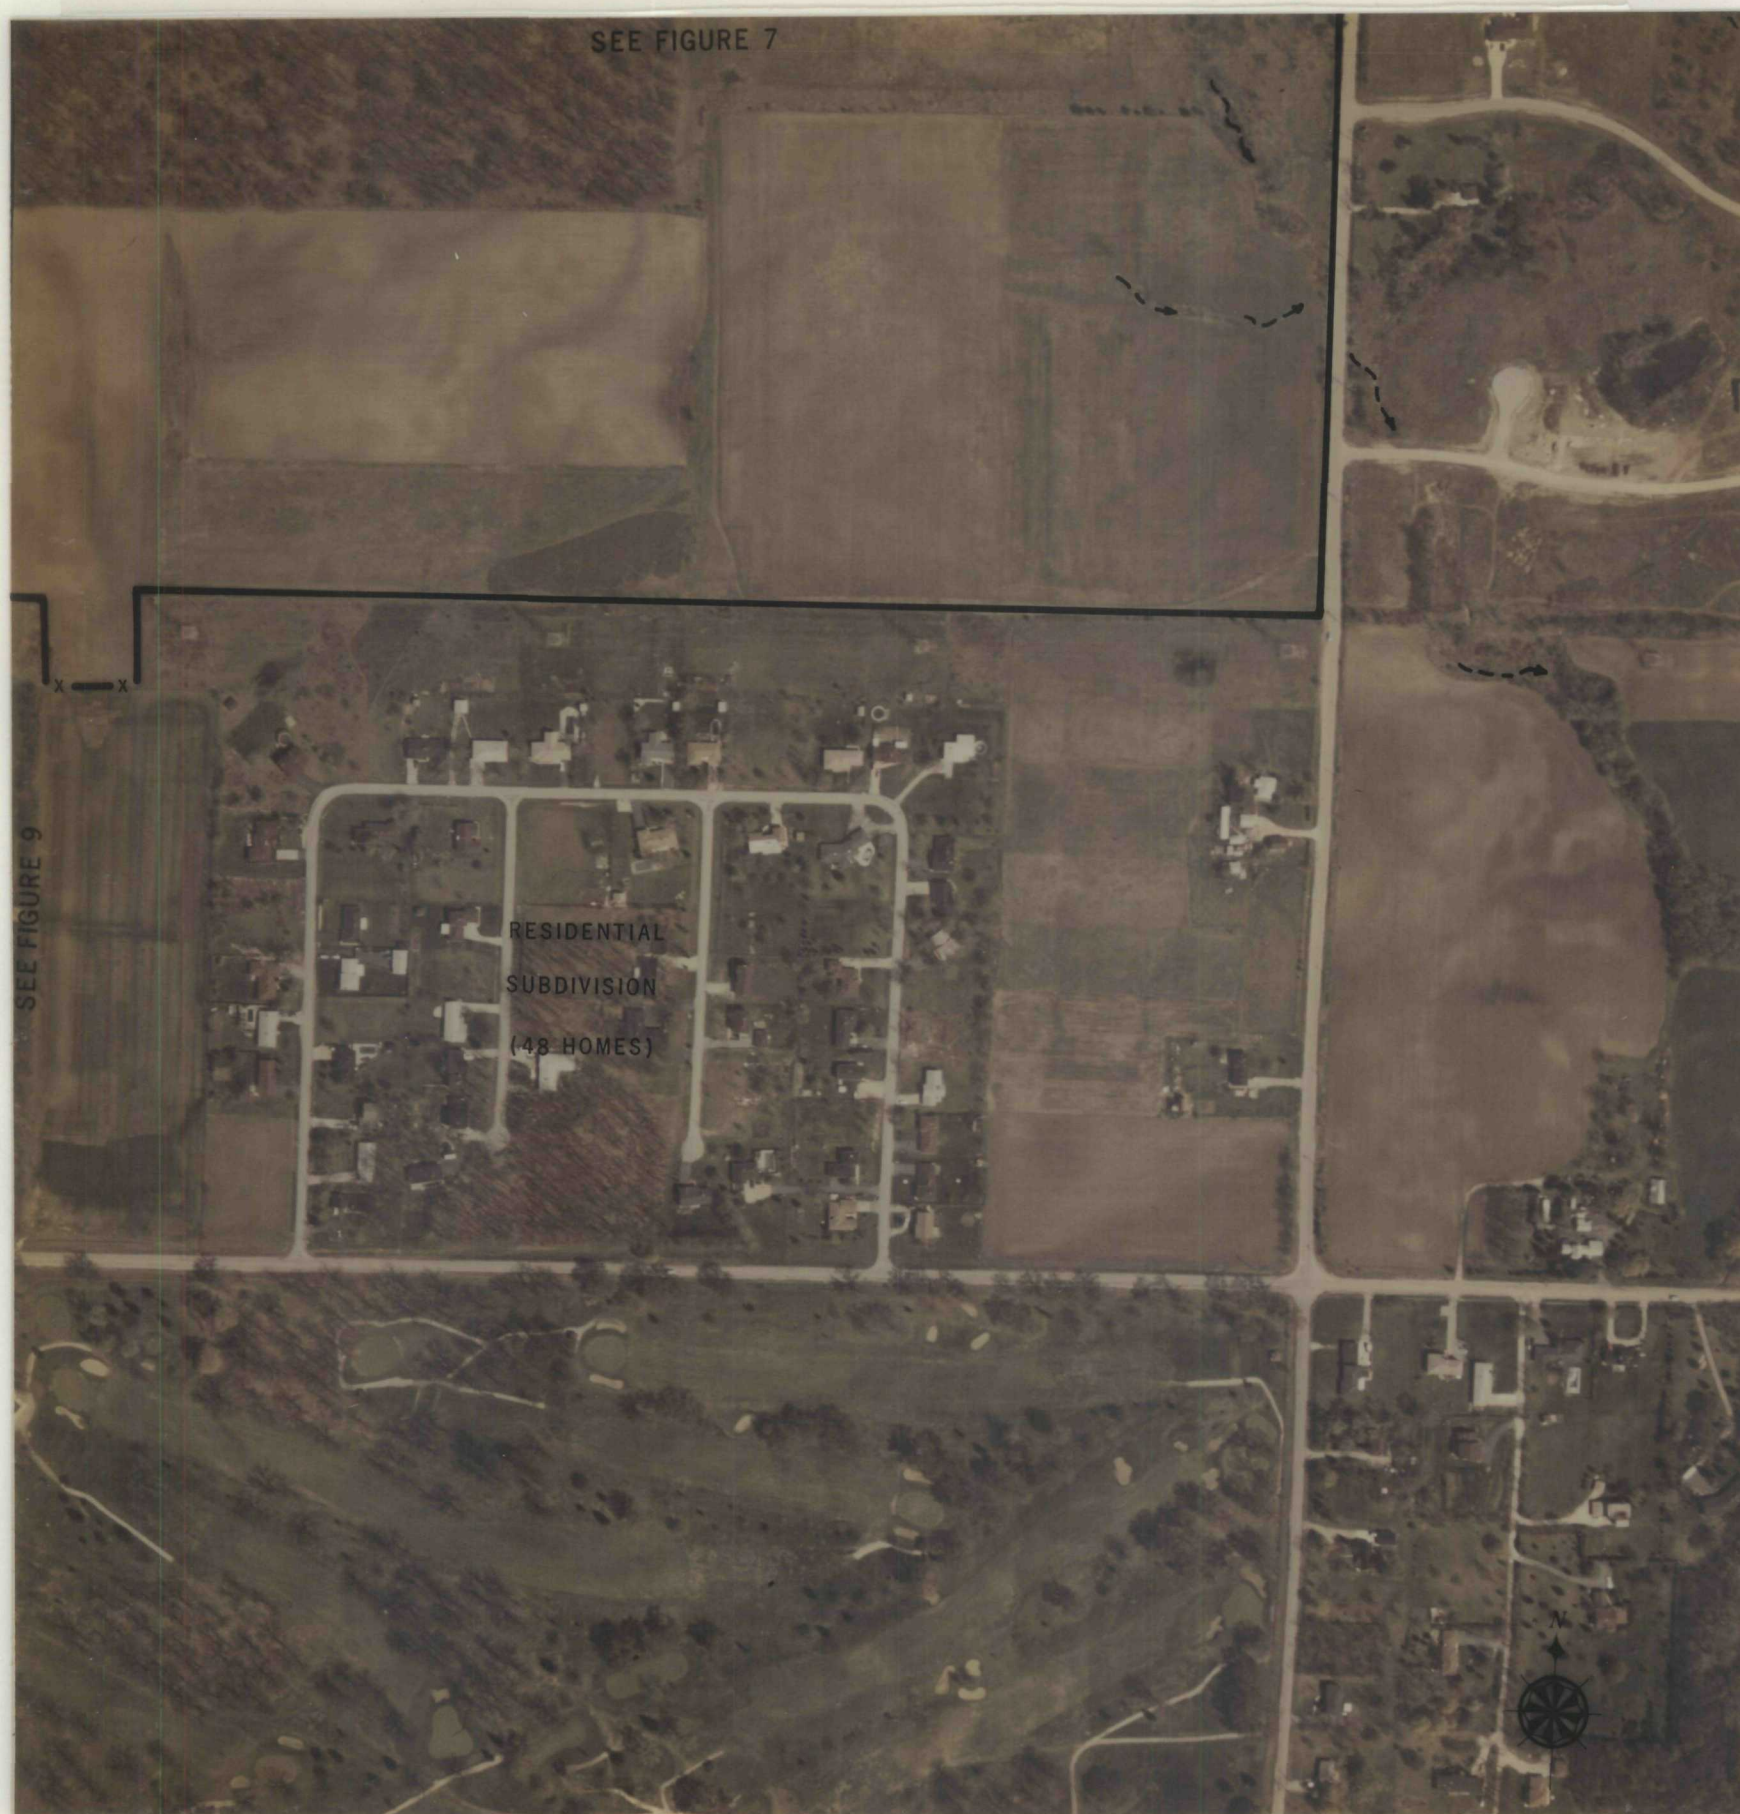
APRIL 17, 1986 (8 of 9)

A residential subdivision is the closest large residential area to the property, however, these homes are still well separated from the refinery itself.
